**TEST REPORT**

**INSTALLATION AND ENVIRONMENTAL TEST  
OF LIGHT SIGNAL MONITOR FACILITY AN/TSQ-( )**

**DSL R-146**

**Gordon H. LaTourette**

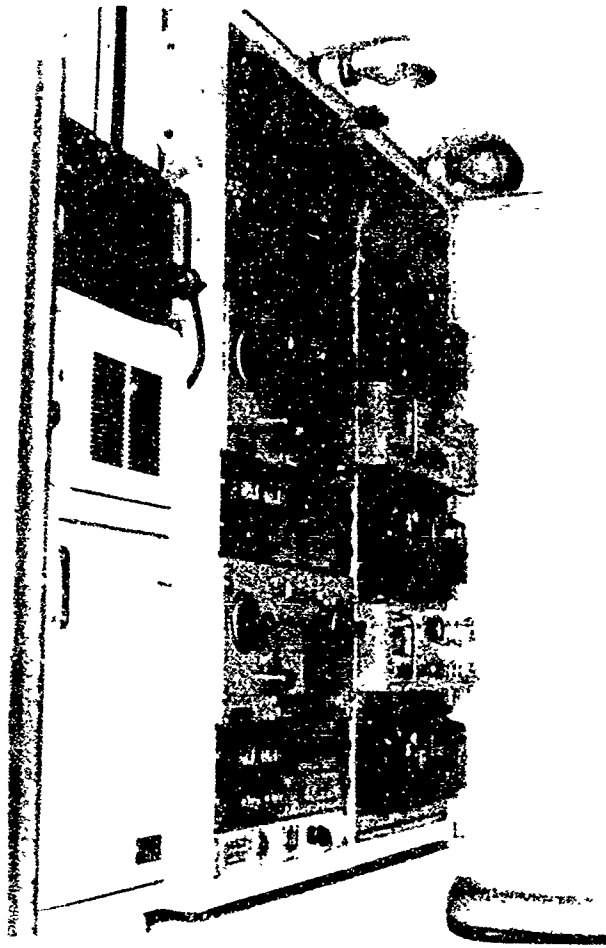
FIGURE 2. INTERNAL VIEW OF SYSTEM - ROAD SIDE

The prototype Light Signal Monitor Facility AN/TSQ-( ) was developed under Office of Naval Research Contract NOnr 2556(00). The system consists of the following component equipment in the quantities indicated installed in an S-155 equipment shelter (Figures 1 and 2):

All of the listed equipment, with the exception of the AN/PRC-47 Radio Set, is mounted in 19-inch equipment racks especially designed for the AN/TSQ-( ). The curb-side rack is an integral three-bay structure shock-mounted to the shelf formed by the shelter indentation and to the shelter curb-side bulkhead (Figure 1). The road-side rack is an integral two-bay structure shock-mounted in the same manner (Figure 2).

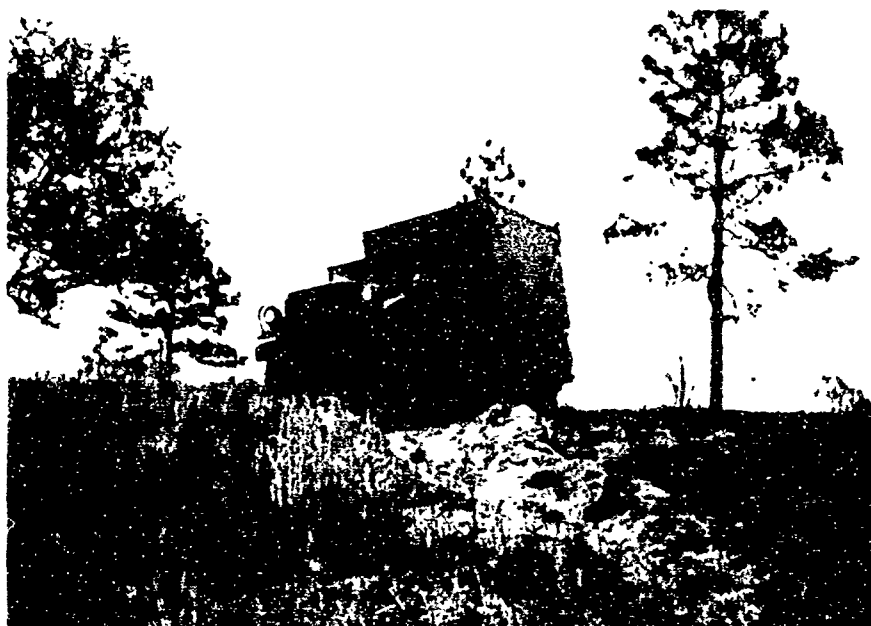
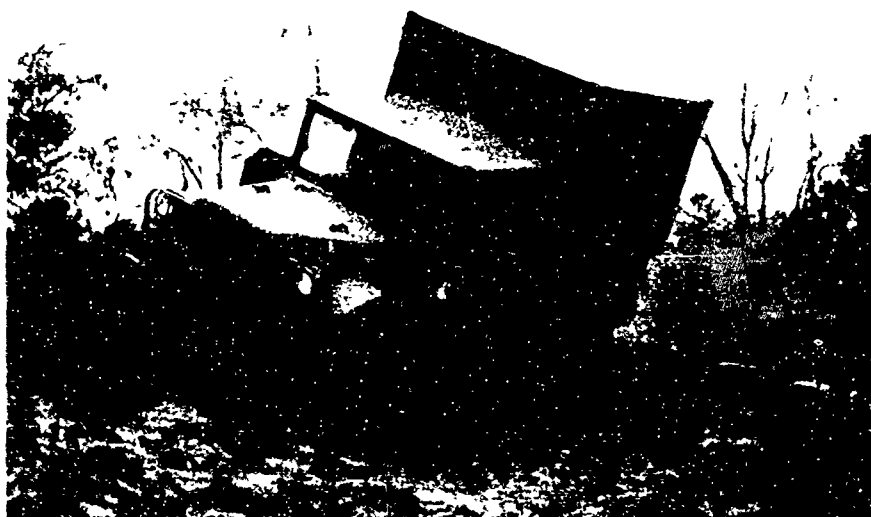
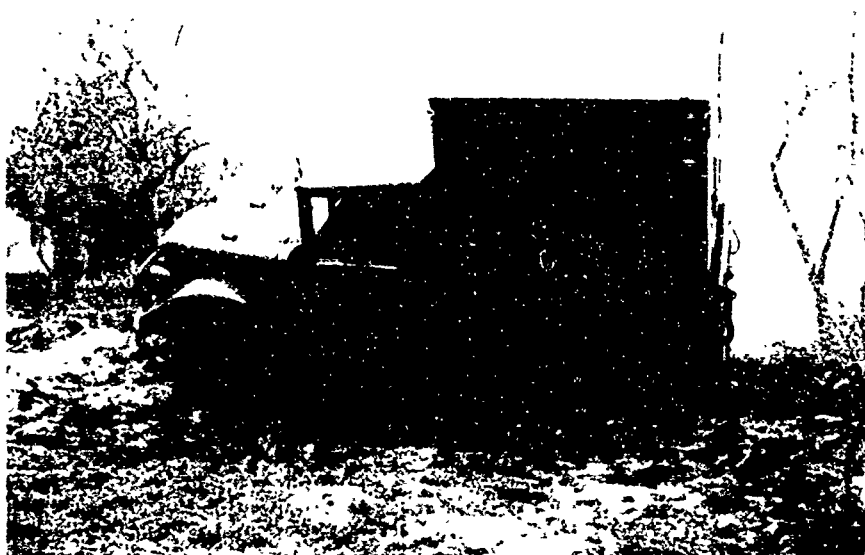
FIGURE 8. TRUCK TRANSPORT TEST (CROSS-COUNTRY)

FIGURE 9. TRUCK TRANSPORT TEST (CROSS-COUNTRY)

FIGURE 10. TRUCK TRANSPORT TEST (CROSS-COUNTRY)

Figures 6 and 7 show two typical portions of the route covered during the road test. Figures 8, 9, and 10 show typical portions of the route covered during the cross-country test.

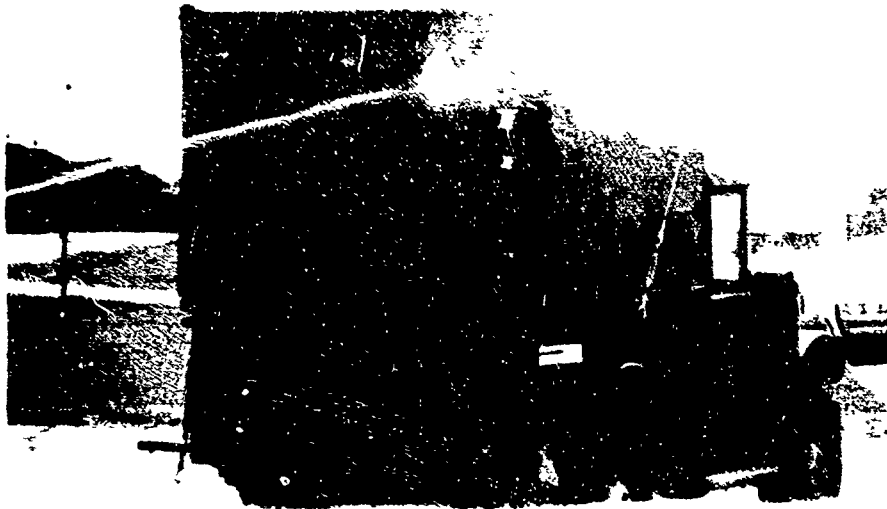
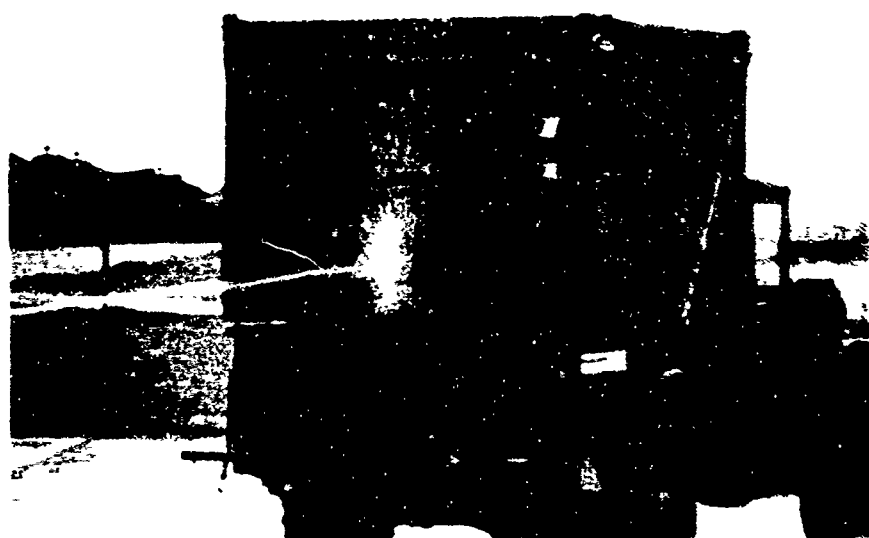
FIGURE 17. ENCLOSURE TEST

FIGURE 18. ENCLOSURE TEST

3. Enclosure Test - A stream of water at 30 psi was directed from a 45 degree angle into each opening and seam of the shelter. The system satisfied all requirements of paragraph 5.2.26 of MIL-STD-108 for water tight enclosures. Figures 17 and 18 show the system undergoing the enclosure test.
